**Site: Main Street Park**

**Report: Sample Monthly Inspection Report**

**Inspection Date: October 11, 2006**

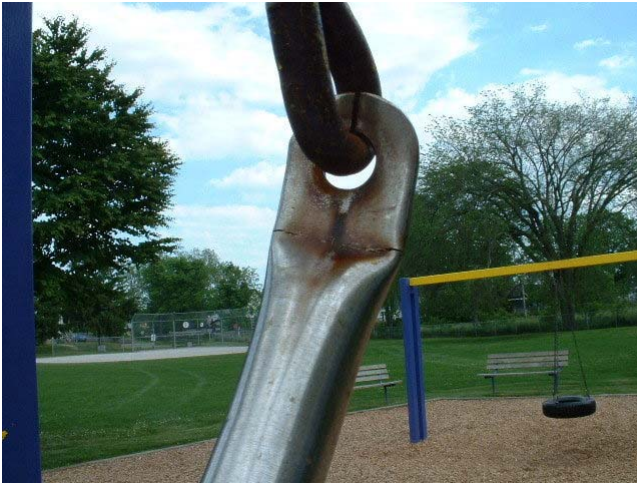
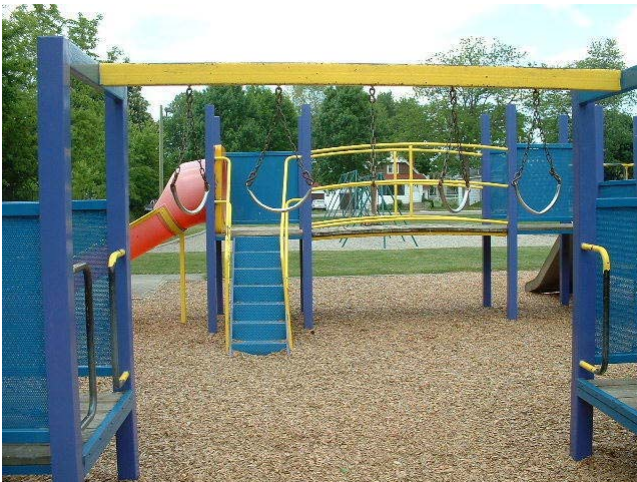
Unsatisfactory – **hazard type B**

Hand-gripping components at ring trek are damaged.

14. **Check all fittings, bearing hangers, fastening devices and hardware (CI 7, 11)**  
Unsatisfactory  
Additional comments:  
Fastening devices at ring trek are worn and rusted. Photos provided above.  
(compliant 1 / 1 )

Ring trek was removed during inspection due to damage and potential breakage.

20. **Check for exposed foundations (i.e. concrete footings and other connecting devices, etc.) (CI 7, 8.3.1, 11)**  
Satisfactory (compliant 1 / 1 )
  21. **Remove any obvious hazards (professional judgement)**  
Unsatisfactory – **Hazard type B**  
Additional comments:  
Ring trek was removed from playstructure during inspection.  
(non-compliant 0 / 1 )

Requires repair/replacement.
